Shake Table Experiments GPS Deployments: June-July, 2016  
Dara Goldberg and Yehuda Bock  
July 13, 2016

SOPAC was invited to collaborate in a project led by Professor Tara Hutchinson (Jacobs School of Engineering) at the NEES UCSD Large High Performance Outdoor Shake Table to monitor the series of experiments with GPS measurements. The purpose of the testing is described in the abstract below, from <http://nees.ucsd.edu/>:

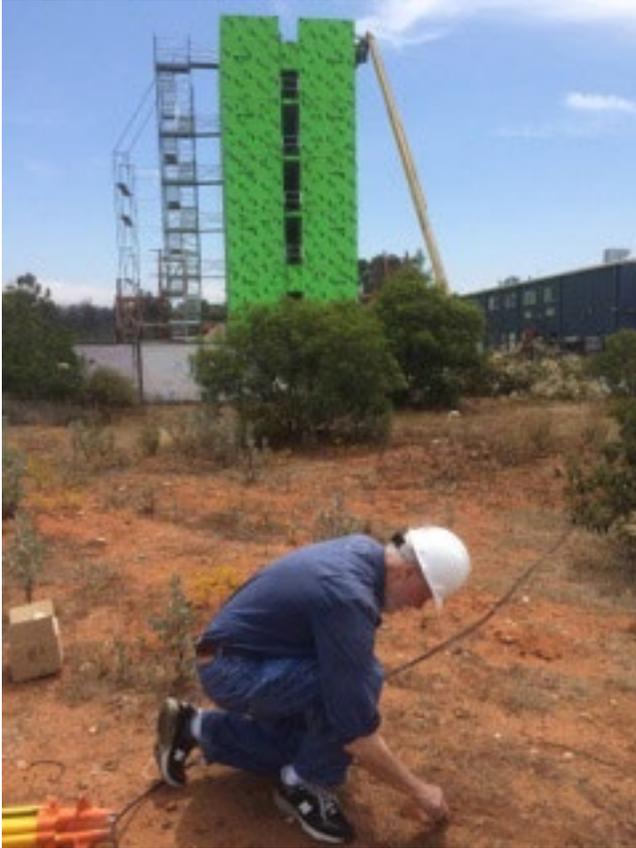
Figure 1: Dr. Bock installs a monument for the BASE tripod station.

We also installed a reference station mounted on a tripod in the field area ~45m directly west of the Shake Table (Figure 1 and 2). The reference station included an Ashtech choke ring antenna (ASH701945B\_M, without a radome) mounted on a tribrach, and was connected to a Leica GMX902 receiver in the Shake Table conference room. The antenna was leveled, oriented to true north and centered over a temporary geodetic marker (NGS disc monument at a slant height of 140.5cm). We submitted a request to UNAVCO for 10Hz data from the nearest cGPS station, P472, during the test to use as a second reference and to assess the precision of the estimated GPS displacements (during the shaking experiments there should be zero motion between the two references). P472 is the Camp Elliot site, located at 32.88921°N, 117.1047°W and 138m elevation and ~650m from the Shake Table. This station operated for all experiments.

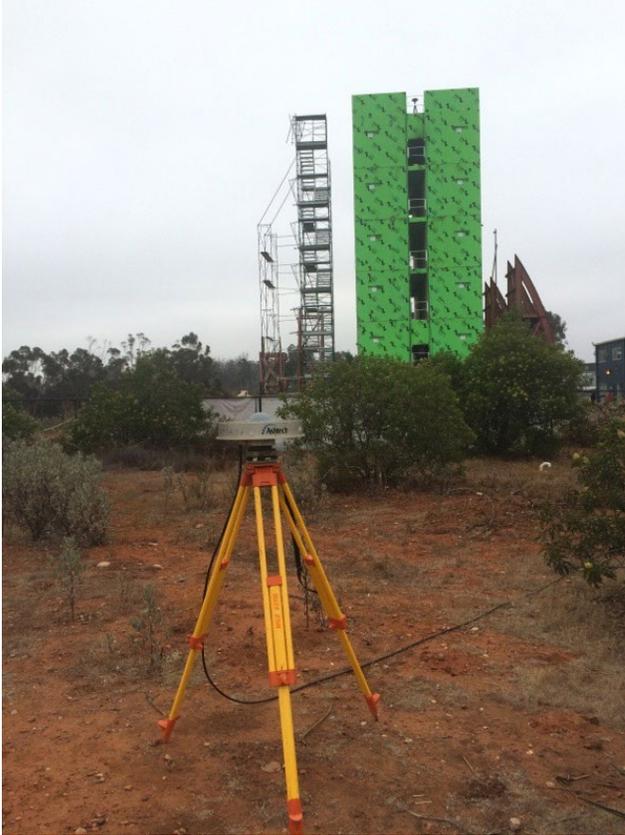
Figure 2: View of the BASE station and the western side of the building. Station Roof West is visible between the roof parapets.

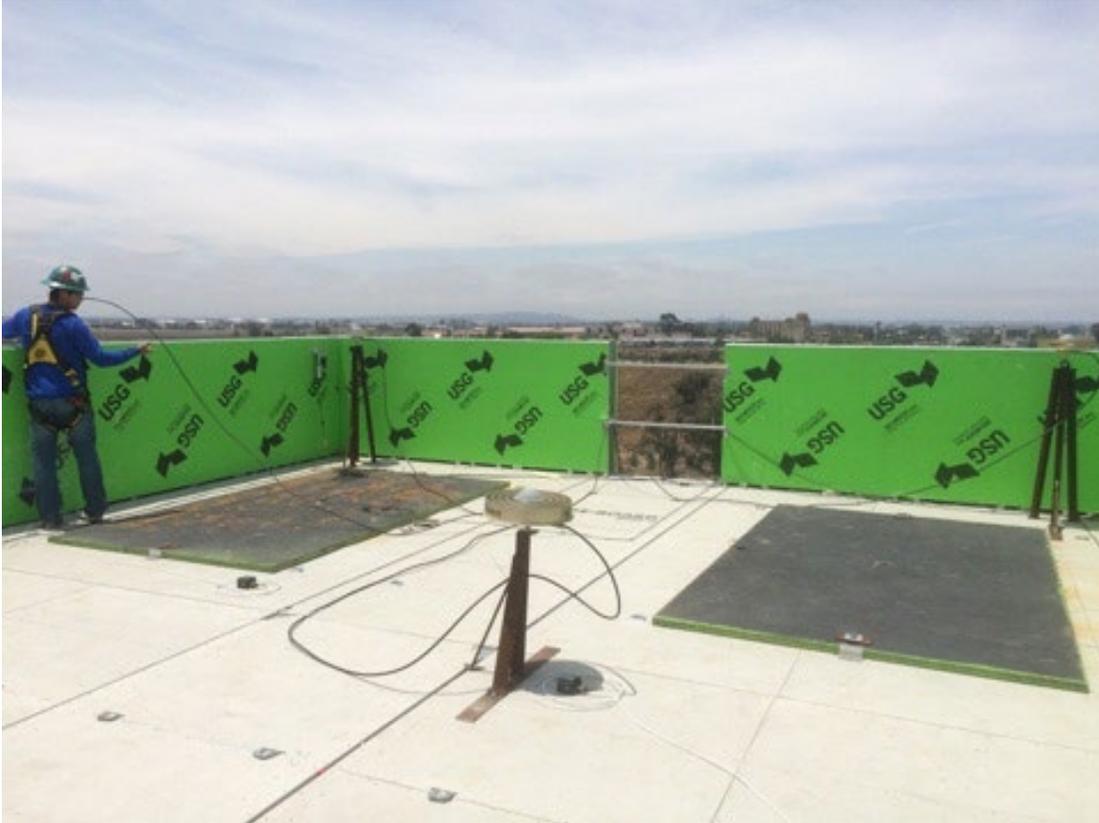
Figure 3: Xiang Wang feeds the antenna cables down the side of the structure toward the receivers, set up in the adjacent conference room.

We deployed five GPS receivers on the building for the June 13, 15, and 17 experiments. Three receivers were deployed on the roof (Figures 3-6). To reduce the weight, two small antennas (not chokering) were cantilevered off the west side of the third and fifth floors (Figure 7); both locations had considerably obstructed sky views. For the June 13<sup>th</sup> experiments, we deployed two small Leica antennas on the third and fifth floor. The Topcon GNSS antenna and receiver was used for the central roof station so that we could process GPS and GLONASS data in postprocessing using precise point positioning (PPP). The third floor antenna was connected to a Topcon GNSS receiver in order to have access to both GPS and GLONASS satellites, to hopefully improve the satellite coverage. The other two other roof antennas were located in the NW and SW corners. All GPS receivers (except for P472) were located in the Shake Table conference room, south of the platen and connected to the antennas with 40-60m antenna coaxial cables (Figure 5). Note that the 60m cables are an adequate length to be able to comfortably bring cable from roof into conference room. We changed the deployment strategy for the June 15<sup>th</sup> and 17<sup>th</sup> experiments. Because of the poor visibility at the third and fifth floor cantilevers, we replaced the small Leica antennas with two small Topcon GNSS antennas, and switched the Topcon receiver for the third floor. The GPS equipment used for these experiments including the base stations is listed in Tables 5 and 6.

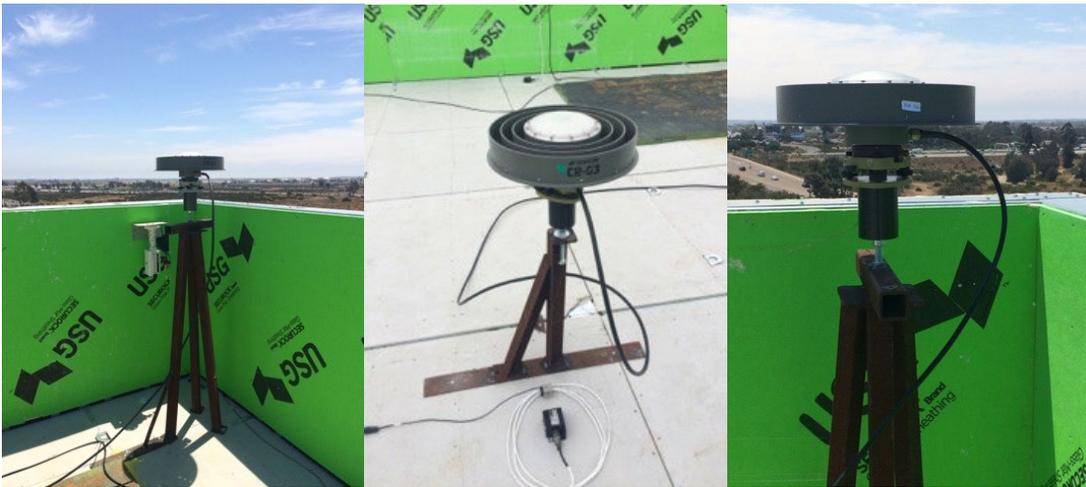
Figure 4: Roof Stations. Left: Roof SW, Center: Roof Center, Right: Roof NW.

- The stations installed on the roof were not level. The Shake Table crew adjusted the mounts to make them more level, and we installed the antennas on top of tribrachs to allow for proper leveling.

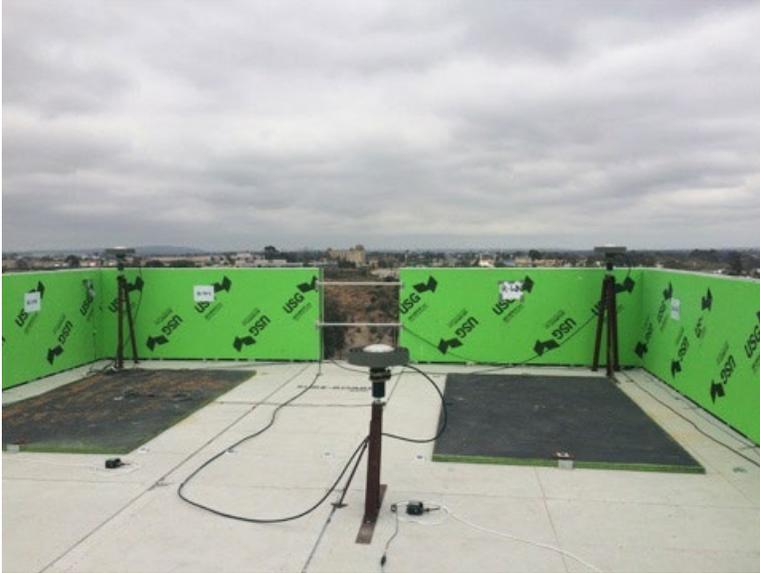
Figure 5: Roof Stations, looking west.

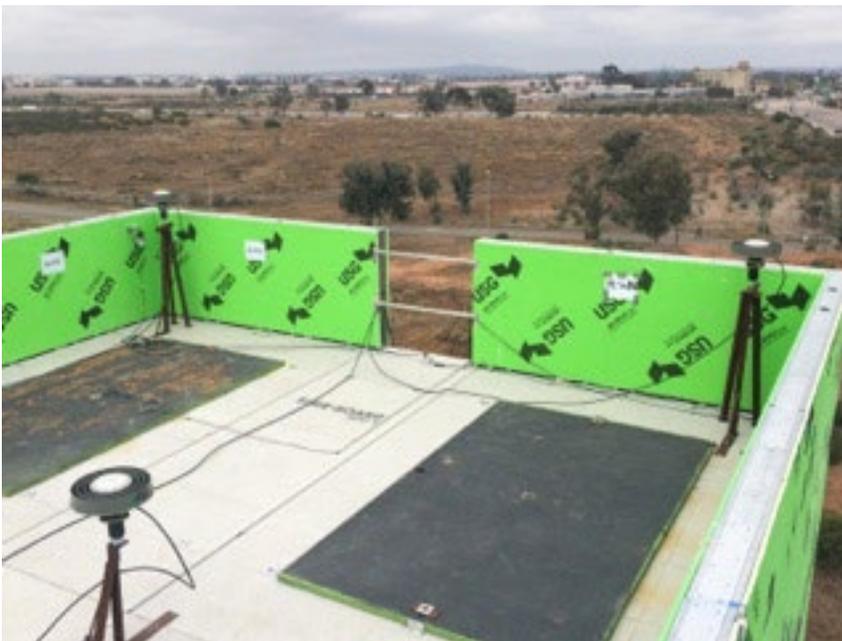
Figure 6: Roof stations, looking WSW.

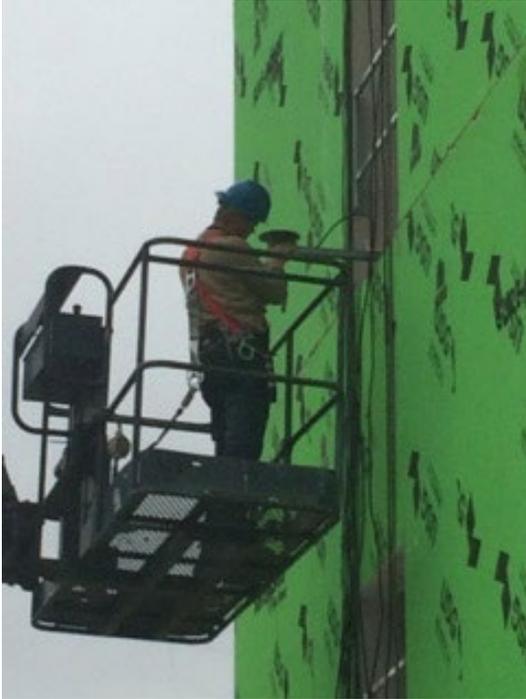
Figure 7: Jeremy (LHPOST personnel) replaces the originally installed 3<sup>rd</sup> floor Leica receiver with a small Topcon receiver.

- The cantilevered antennas had difficulty for all experiments due to their obstructed view. Data were recorded, and may be able to be slightly improved in post-processing.

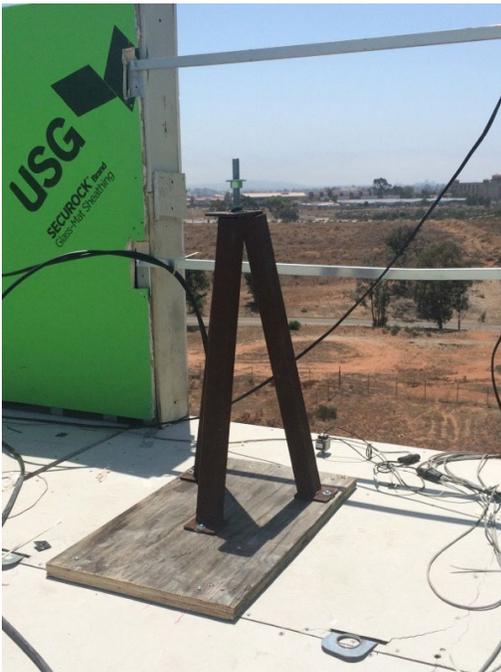
Figure 8: The new 2' mount at the western edge of the roof, installed for the final day of seismic tests.

Drone footage from the first week of seismic testing showed the Roof NW and SW stations experienced high frequency shaking due to the response of the 4’ GPS mounts. The roof center station, mounted on a 2’ stand did not experience this high frequency shaking response. To avoid this response during the final day of testing, all three roof stations were mounted on 2’ stands. However, because there is a 4’ parapet around the roof, leaving the Roof NW and SW stations in the corners would likely result in poor satellite view and multipath effects. See Figures 3-6. We decided to move the stations out of the corners, creating a station midway along the southern edge of the roof and another midway along the western edge of the roof. The Roof center station stayed as is. The equipment for the new set up is detailed in Table 7. The roof stations in their new configuration were installed on June 30, in advance of the final seismic tests (Table 4). Photos of the final roof configuration are shown in Figures 8-11.

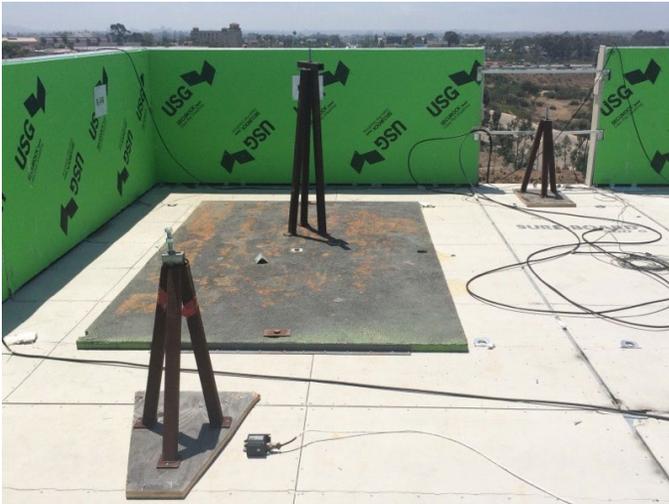
Figure 9: New 2' stands installed on the roof for the final day of seismic tests. Left: Mount for station Roof South. Center: Removed roof SW mount. Right: Mount for station Roof West.

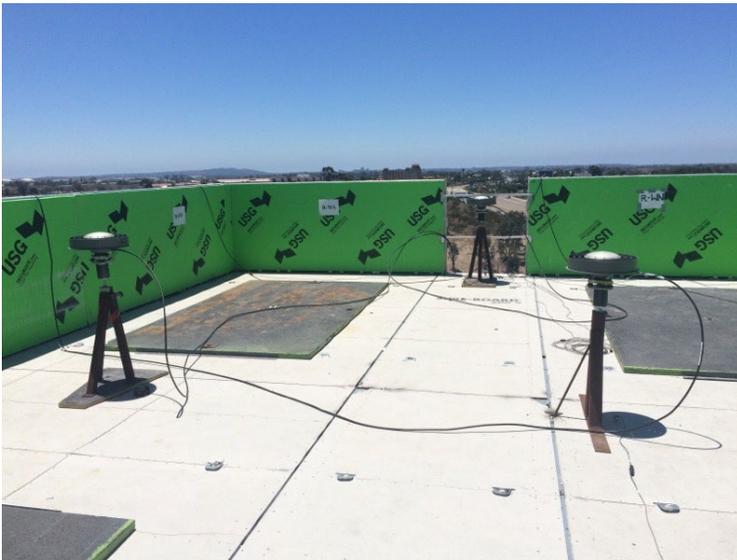
Figure 10: Roof antennas mounted on new 2' stands. Left: Roof South, Center: Roof West, Right: Roof Center.
